Cross Linked Rotomolded Polyethylene Storage Tanks Offer Superior Resistance To Rupture

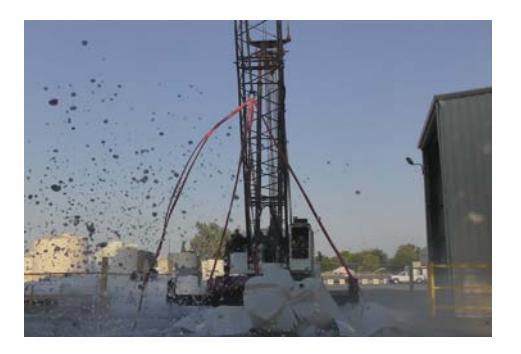
Figure 1 HDPE (Linear) Polyethylene

The first test in this comparative study was the drop test. Each tank in the first set was filled with 7000 pounds of water, and lifted with a crane, one at a time, to a height of 15 feet. This height is comparable to that used in the testing of polyethylene drums used for fuel storage. Once the rotomolded tank reached the desired height it was released and allowed to free-fall onto the concrete surface below. Figures 1 and 2 are pictures of the two tanks after the drop test. It can clearly be seen from these pictures that the linear tank, <u>figure 1</u>, has catastrophically failed. This catastrophic failure and its associated crack propagation appeared to be consistent with the un-zipping characteristic found in linear polyethylene resin grades. On the other hand, the cross linked polyethylene tank, <u>figure 2</u>, did not fail or develop any cracks.

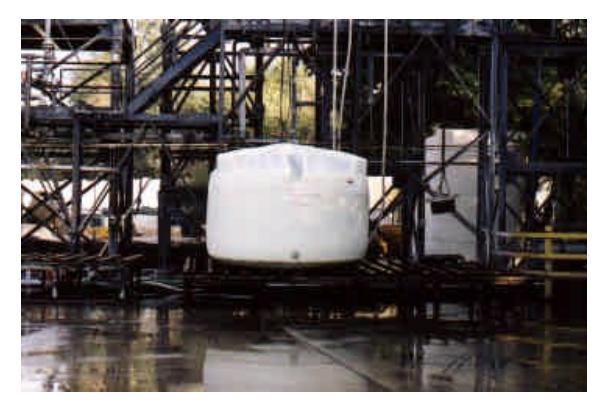
Figure 4 XLPE Crosslinked Polyethylene

<u>Figure 4</u> shows the cross linked polyethylene tank which failed after reaching internal pressure of 10 psi. Unlike the linear tank, only a 6 inch lesion was formed on the dome of the tank due to the pressurization. This clearly demonstrates the excellent resistance of cross linked polyethylene to crack propagation or un-zipping. Further analysis of this lesion revealed that it developed at one of the top corners of the stiffening gussets found on the dome, which is a stress riser location. Also, this lesion exhibited a ductile failure mode due to the presence of elongated plastic strands.

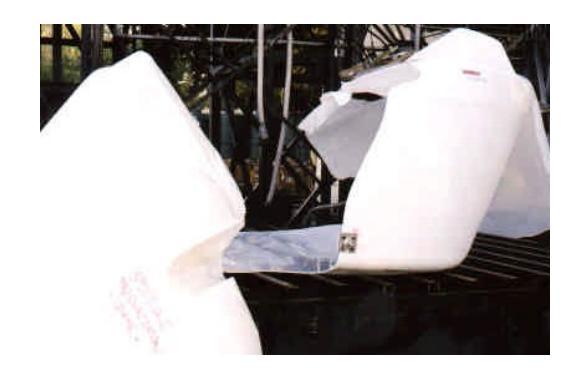
Figure 3 HDPE (Linear) Polyethylene

Each tank in the second set was completely filled with water and using a 5.5 horse power heavy duty water pump, was pressurized until failure or rupture. The manway opening was completely sealed and the pump was connected to the tank through a standard 2 inch diameter pipe fitting. This technique simulates the normal filling characteristics of a tanker truck loading a bulk storage tank in the field. The pressure inside the tank was measured using a standard dial gauge. Figure 3 shows the catastrophic failure of the linear polyethylene tank after the pressure inside the tank reached 9 psi. The failure of the tank was the result of multiple fracture lines, or cracks. The smooth fractured surfaces indicate a brittle failure.
